Manhole Inspection Summary

Manhole # S23C1_018MH

Location Address: **2400 Annor Court**

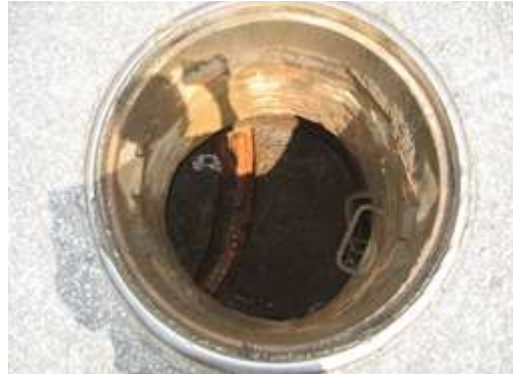
Defect 7

Offset: **2** (in.)

2" offset

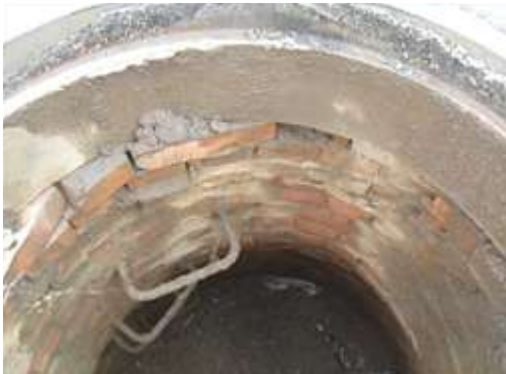
Defect 4

☒ **Leaks**

Count: **3** Missing: **0** ☒ **Corroded**

Frame leaks, corroded steps

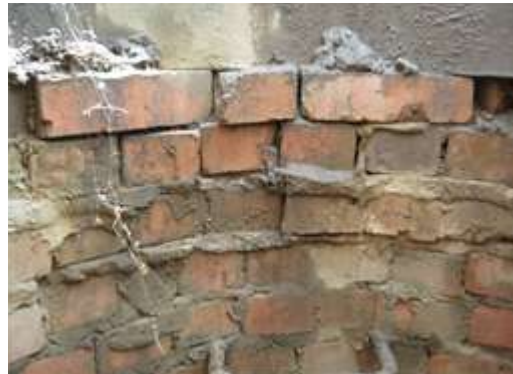
Defect 5

Condition: ☐ Sound ☐ Cracked ☐ Root Intrusion ☐ Loose Brick ☒ **Deteriorated**

Infiltration: ☐ None ☒ **Joint** ☐ Cracks ☒ **Mortar** ☐ Roots ☐ Wall

chimney deteriorated with signs of infiltration at joint & mortar

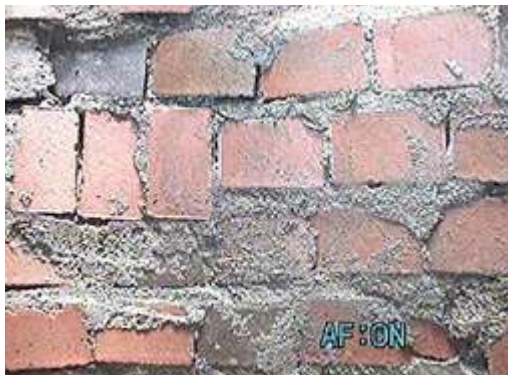
Defect 2

Infiltration: ☐ None ☐ Joint ☐ Cracks ☐ Mortar ☐ Roots ☒ **Wall**

barrel wall infiltration

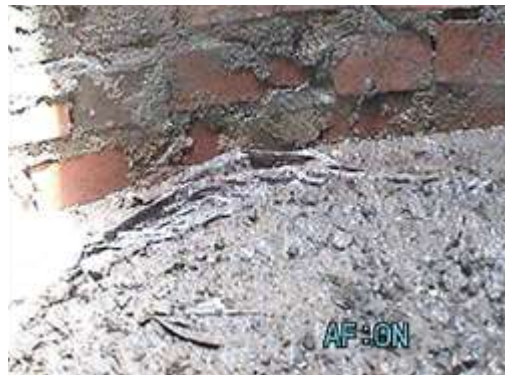
Defect 1

Condition: ☐ Sound ☐ Cracked ☐ Root Intrusion ☐ Deteriorated ☐ Leaks ☒ **Debris**

bench debris
